Oxygen Corrosion of Carbon Steel Boiler Tubes

Corrosion Testing Laboratories, Inc.
60 Blue Hen Drive
Newark, Delaware USA 19713
Phone: 1-302-454-8200

Condominium Complex
Hot Water Boilers . 11 years old
Oxygen Corrosion

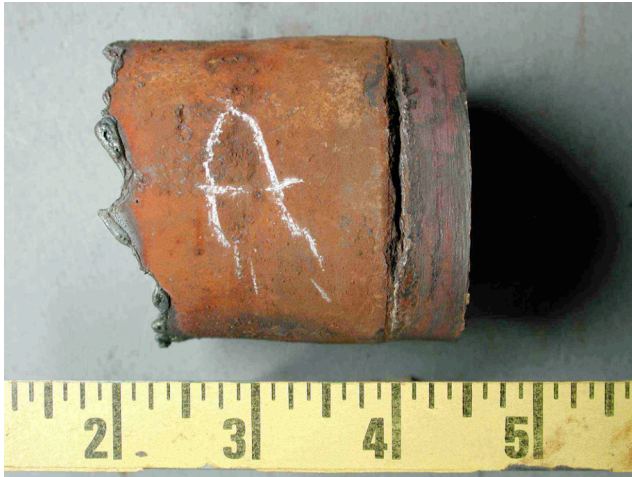
Each of the failed tube ends displayed the groove and crack failure features, described above, immediately adjacent to the ½-inch wide band where the tube had been rolled into the tube sheet, Figure 1. On each tube the groove was approximately 1.5-inches long, extending only part way around the circumference. In each case, the groove appeared to be the result of corrosion, mainly due to its irregular surface, rather than mechanical deformation.

Figure 1. End of boiler tube showing typical features of failure: groove and crack adjacent to band where tube was rolled into tubesheet.

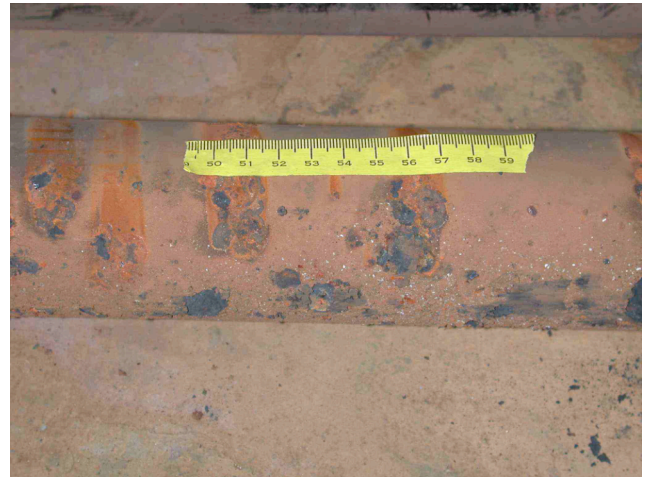
Six (6) boiler tubes that had failed were available for examination at the condominium. It was noted that the general appearance of the tubes fell into two categories: Tubes that had a red, rusty appearance and tubes that had a black, shiny appearance. Closer examination of a rusty tube revealed the presence of significant pitting, accompanied by rust-colored mounds (known as "tubercles") along its length, Figure 2.

Figure 2. Pits and tubercles observed on failed boiler tube examined at the condominium. Note rusty streaks oriented at right angles to the tube length, which indicate active corrosion under stagnant conditions.

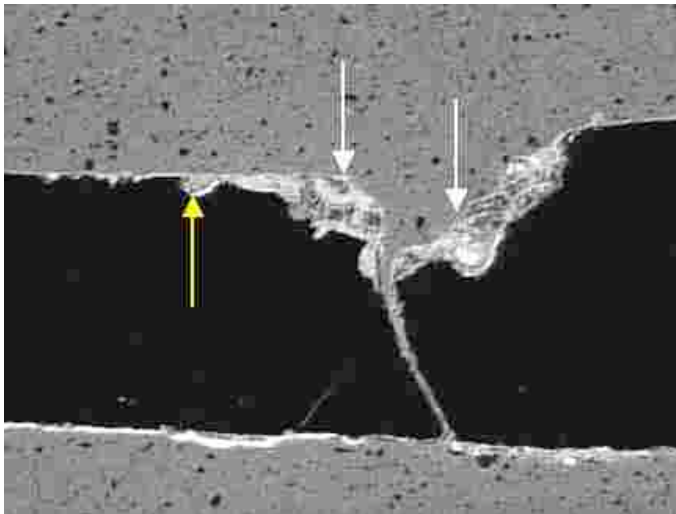
One of the failed tube ends supplied to CTL was sectioned longitudinally through the groove and crack for metallographic examination. The presence of thick black oxide on the groove and parts of the crack surface, Figure 3, as well as lack of deformation in the microstructure, confirmed that corrosion was the cause of the grooving. Deformation of the microstructure at the crack surfaces indicated that the final failure was by ductile tearing. The microstructure itself consisted of pearlite in an equiaxed ferrite matrix, typical of low carbon steel, Figure 4. There were no indications of overheating of the tube.

Figure 3. Polished metallographic longitudinal cross-section showing oxide-filled groove and crack. Light-colored material indicated by white arrows is oxide. Yellow arrow indicates crevice attack on part of tube rolled into tube sheet. (18X Original Magnification)

It is possible that occluded cell (crevice) corrosion played a role in the grooving. In this scenario, a differential aeration cell is set up between the tube adjacent to the return end tube sheet and the tube just under the edge of the tube sheet (assuming leakage of boiler water under the tube sheet.). This cell will lead to corrosion of the tube just under the tube sheet, which accounts for the observed grooving. In fact, evidence of crevice corrosion is seen on the metallographic specimen (see Figure 5).

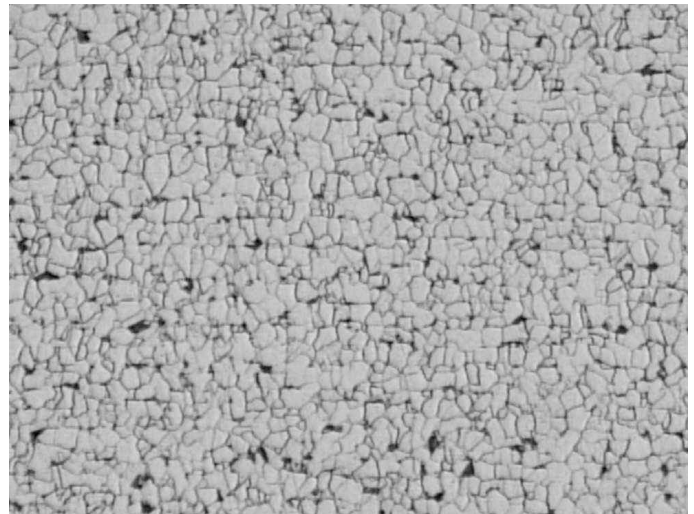
Figure 4. Microstructure of failed tube showing pearlite in equiaxed ferrite matrix. (2% nital etch) (125X Original Magnification)
